New Zealand Society for Earthquake Engineering

THE CANTERBURY EARTHQUAKES:

Answers to critical questions about buildings

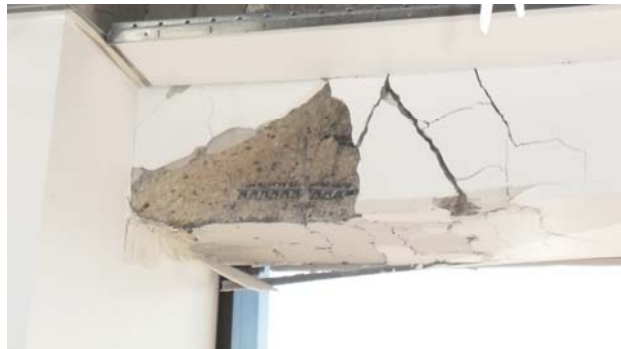
Figure 1: An energy absorbing (ductile) beam hinge in a reinforced concrete building after an earthquake. As these ductile elements yield they absorb energy without loss of strength that would lead to collapse of the building. While some of the cover has fallen off, none of the reinforcing has broken, and the concrete inside the reinforcing cage is intact, so this beam can still carry load.

- Providing “stiffness” so that buildings do not move much in small earthquake shaking and there is no damage.
- Providing “strength” so that buildings do not have any significant damage to the building frame in moderate levels of earthquake shaking.
- Providing “toughness” so that buildings do not collapse under more extreme earthquake shaking, such as that considered in the design code of the time. This toughness is the ability to absorb energy is called “ductility”. As the building absorbs energy, damage occurs without collapse.

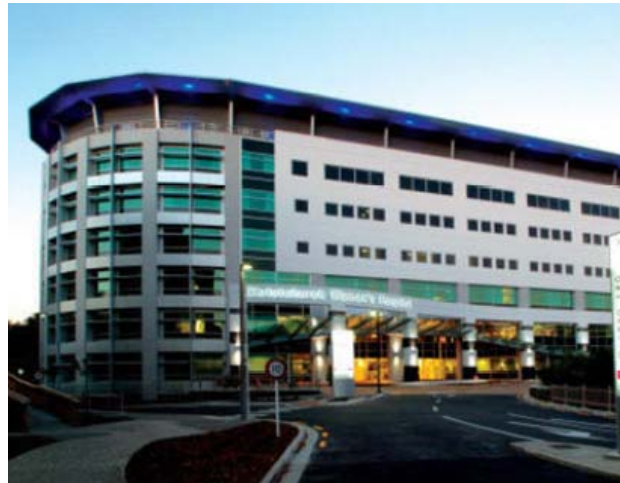
Figure 2: Christchurch Women's Hospital sits on Lead Rubber base isolators.

Lead rubber bearings, as deployed at Christchurch Women’s Hospital (Figure 2 & 3), Parliament and Te Papa, are an example of a novel device developed by the former NZ Department of Scientific and Industrial Research in order to protect structures against severe ground shaking. This is called base isolation, because it allows the ground to move horizontally beneath the building thereby isolating the structure from the ground and significantly reducing the forces on the building. Te Papa’s base isolators can be seen as a special exhibit just around the corner from the museum’s main entrance.

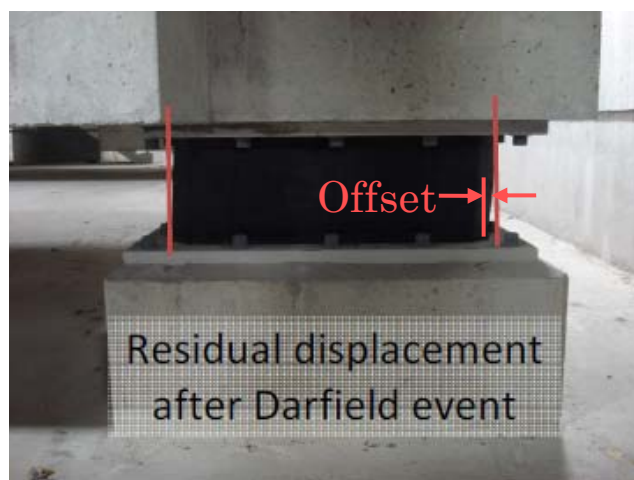
Figure 3. Lead Rubber base isolator under Christchurch Women's Hospital, showing the final resting position of the building after its oscillation during the 4 September 2010 earthquake.

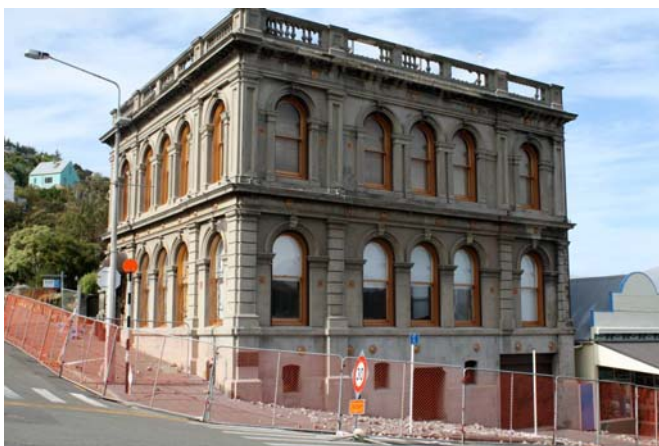
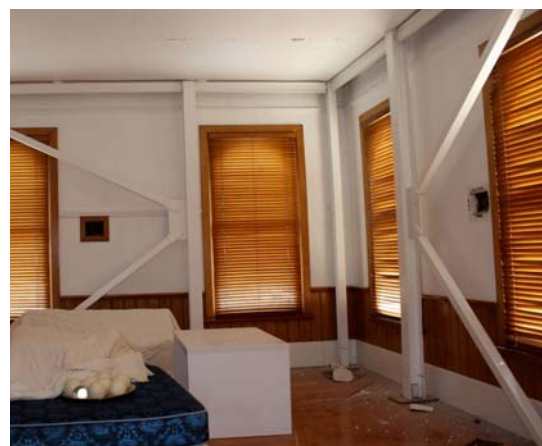
Figure 4: The Lyttelton Fire Station building suffered only minor damage as it has been strengthened with an internal steel frame (Photos Win Clark)

There has also been research on how to strengthen older buildings, and how to add further protection to vital buildings such as hospitals. Some of these methods include: removing particularly vulnerable parts of buildings (e.g. brittle façades and parapets); tying the walls together with steel bracing; bolting façades to the building's frame; adding new support structures; and, wrapping columns and joints with steel and other materials to keep them intact.

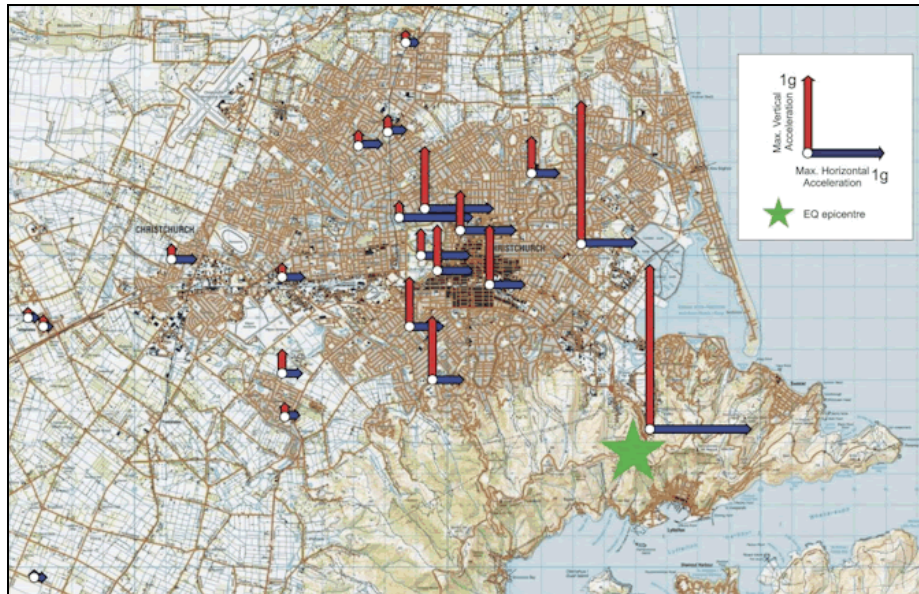
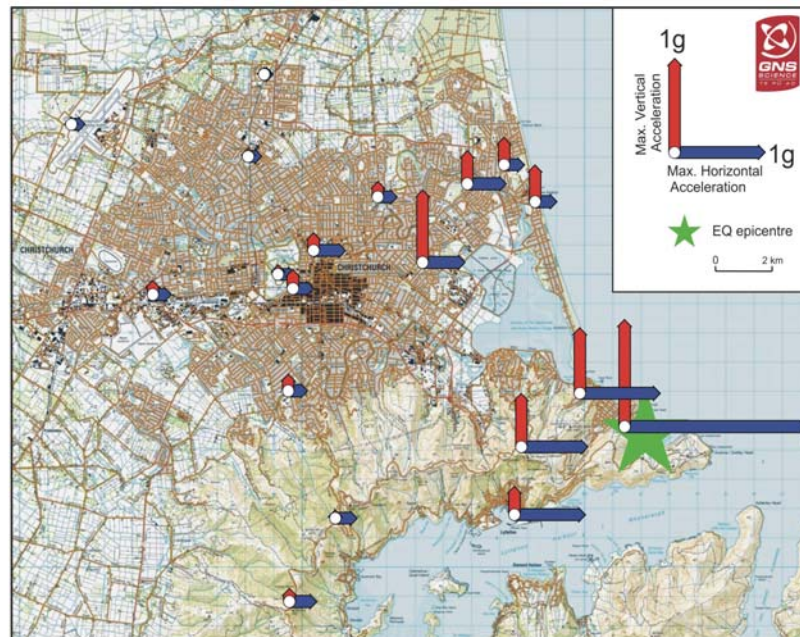
Figure 5a and 5b: Graphic showing the unusually high vertical ground accelerations in central Christchurch recorded during the magnitude 6.3 earthquakes on 22 February and on 13 June 2011. (Source: GNS Science)

Despite being only 6.3 on the earthquake magnitude scale, the proximity of the 22 February and 13 June 2011 events to the surface, and to Christchurch, caused ground shaking in the central business district several times as severe as what occurred in the magnitude 7.1 September 2010 earthquake (Figures 5a and 5b). The geology of the area made matters worse by guiding the shock waves towards the city. The peak ground accelerations, as they are called, were amongst the highest to have ever been recorded in a modern city anywhere in the world.

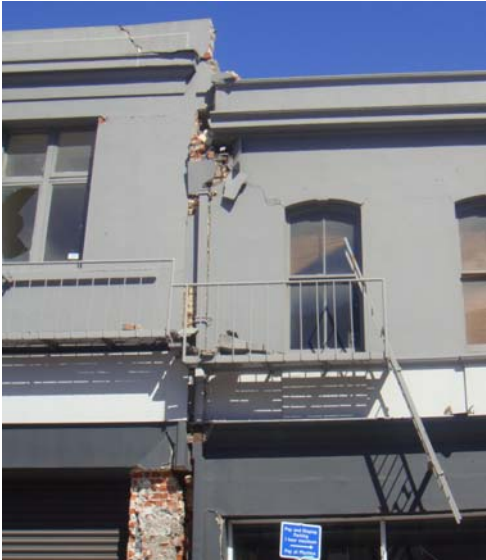
Figure 6: Pounding-induced damage of buildings in Christchurch CBD³

Other ways earthquakes cause damage to buildings include when two adjacent buildings collide as the ground movement makes them sway, causing pounding damage (Figure 6), or when sometimes, parts of one building—like parapets, chimneys or façade veneers—fall on another building and cause damage.

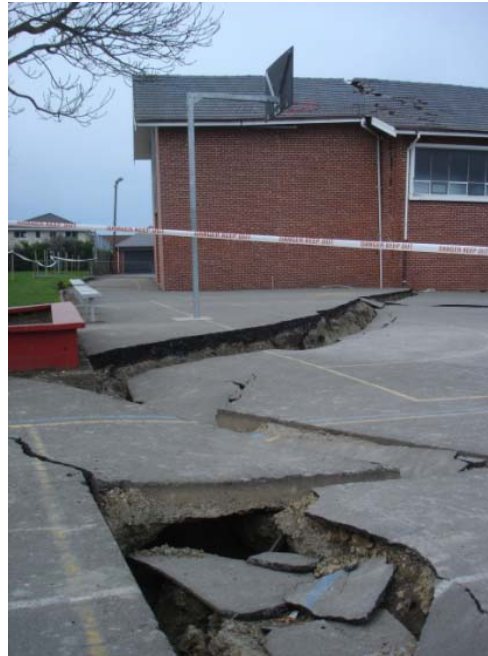
Figure 8 Lateral spread crack running through the courtyard and building at St. Paul's church, Dallington, Christchurch, New Zealand (September 2010)⁶

Most buildings did not collapse even though the levels of earthquake shaking were up to about twice the design level for buildings meeting the current code requirements. Even buildings in areas of liquefaction and lateral spreading, as well as strong shaking, did not collapse despite some being badly damaged (Figure 8) or left tilting.

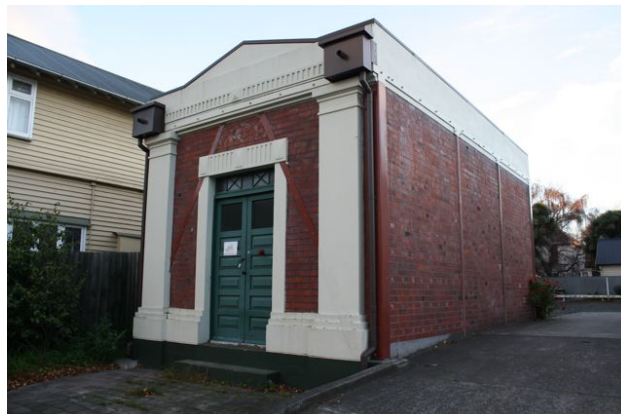
Figure 9: Orion Local Substation. Constructed in unreinforced brick masonry that has been strengthened with a steel perimeter frame (Photo Win Clark)

Just because a building is constructed in brick or stone, it is not necessarily a danger. If brick masonry is properly attached to a backing frame, as it is in most residential construction, it can behave well as can masonry blocks filled with concrete and strengthened with steel rods. Brick masonry restrained by a concrete or steel frame, if properly designed, can also behave well and it has been used effectively throughout the world, including Christchurch, as shown in Figure 9.
